SWEEPING PLAZA DECK JOINTS UNDER THE RUG

The hidden pitfalls of "buried band-aid" joint sealing solutions

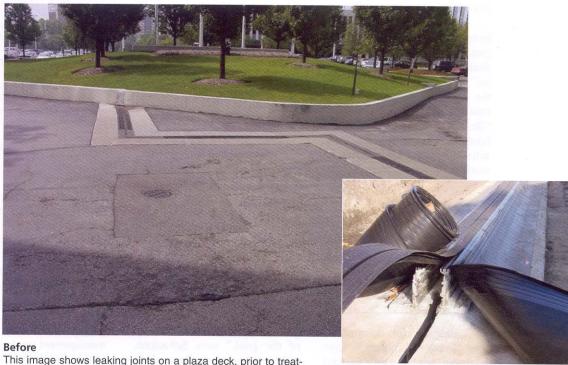
This image shows leaking joints on a plaza deck, prior to treatment with EMSEAL's MIGUTAN joint sealing technology.
